# Access Compliance Report Public Rights-of-Way (Curb Ramps)

| Main Street: O_NEILL_DR | | Cross Street: CECIL_PASTURE_RD | | Location: | SW |
| ADA ID: RPRK211025143015 | Ramp Type: Type 4 - Parallel | Initial Pass/Fail: Fail | Overall Compliance: No | Severity Score: | 15 |

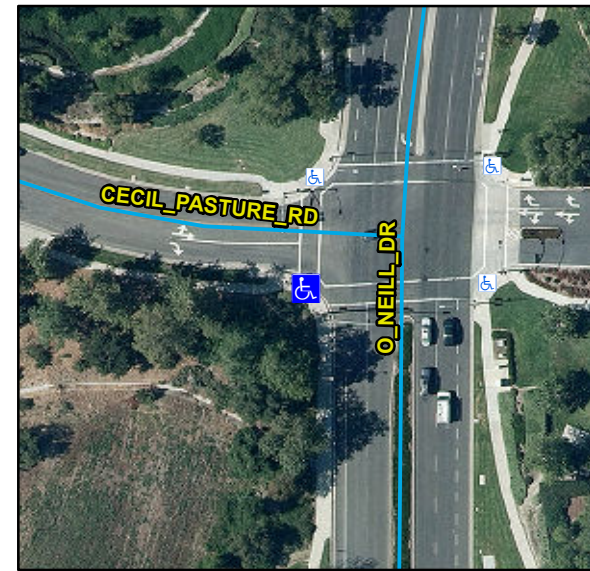
| Compliance | Description | Data | Compliance | Description | Data |
|---|---|---|---|---|---|
| Yes | Ramp Run Slope LT (%) | 5.8 | No | Ramp Run Slope RT (%) | 8.7 |

**Remove & Replace Curb Ramp With Two New Directional Ramps or Equivalent.**

**R204.3, R304.3.2, STD 1115**

Total Cost: \$ 4000
