# Access Compliance Report Public Rights-of-Way (Curb Ramps)

| Main Street: CROWN_VALLEY_PKWY | | Cross Street: CROWN_VALLEY_PKWY | | Location: | NE |
| ADA ID: RPRK211026120136 | Ramp Type: Type 4 - Parallel | Initial Pass/Fail: Fail | Overall Compliance: No | Severity Score: | 30 |

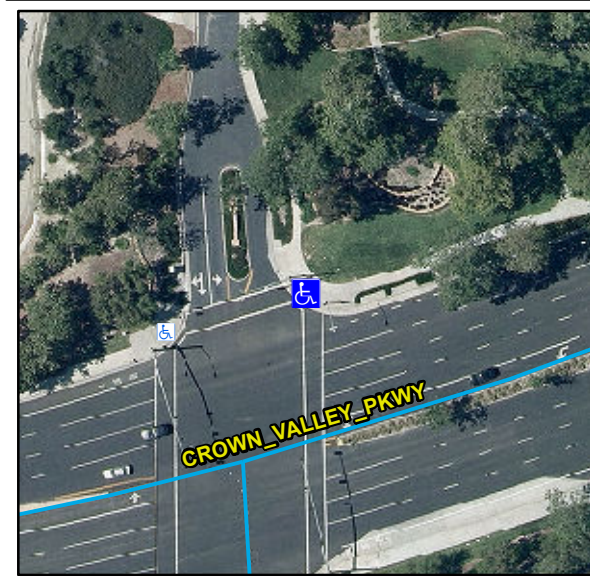
| Compliance | Description | Data | Compliance | Description | Data |
|---|---|---|---|---|---|
| No | Ramp Cross Slope LT (%) | 7.2 | No | Ramp Cross Slope RT (%) | 7.4 |

**Remove & Replace Curb Ramp With Two New Directional Ramps or Equivalent.**

**R204.3, R304.5.3, STD 1115**

Total Cost: \$ 4000

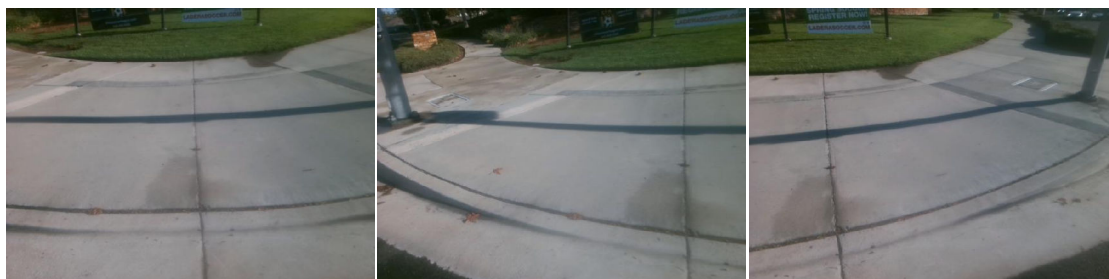
| Compliance | Description | Data | Compliance | Description | Data |
|---|---|---|---|---|---|
| N/A | Ramp Length LT (in) | 103 | N/A | Ramp Length RT (in) | 103 |
| Yes | Ramp Width LT (in) | 107 | Yes | Ramp Width RT (in) | 107 |
| Yes | Ramp Run Slope LT (%) | 1.4 | Yes | Ramp Run Slope RT (%) | 5.9 |
