# Access Compliance Report

## Public Rights-of-Way

### (Curb Ramps)

Main Street: CROWN\_VALLEY\_PKWY Cross Street: CROWN\_VALLEY\_PKWY Location: NW

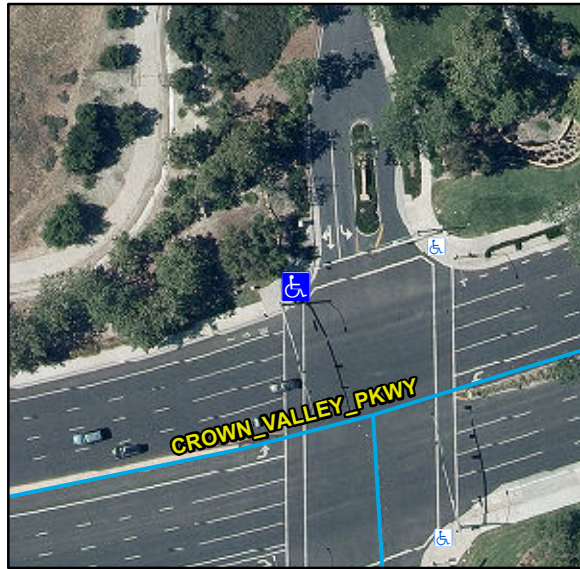
ADA ID: RPRK211026120652 Ramp Type: Type 4 - Parallel Initial Pass/Fail: Fail Overall Compliance: No Severity Score: 45

| Compliance | Description | Data | Compliance | Description | Data |
|---|---|---|---|---|---|
| No | Ramp Cross Slope LT (%) | 6.2 | No | Ramp Cross Slope RT (%) | 7.5 |
| No | Overall Surface Condition | Poor | | | |

**Remove & Replace Curb Ramp With Two New Directional Ramps or Equivalent.**

**R204.3, R304.5.3, R302.7, STD 1115**

Total Cost: \$ 4000
