# Access Compliance Report Public Rights-of-Way (Curb Ramps)

Main Street: CECIL\_PASTURE\_RD Cross Street: CROWN\_VALLEY\_PKWY Location: SW

ADA ID: RPRK211026121243 Ramp Type: Type 1 - Perpendicular Diagonal Initial Pass/Fail: Fail Overall Compliance: No Severity Score: 30

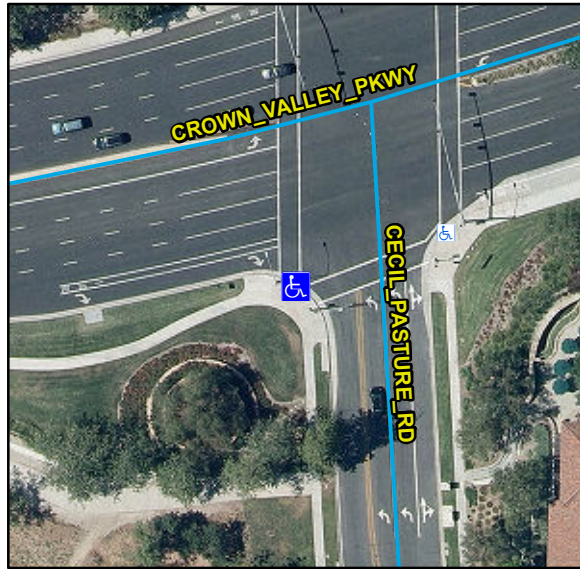
| Compliance | Description | Data | Compliance | Description | Data |
|---|---|---|---|---|---|
| No | Ramp Run Slope (%) | 9.1 | N/A | Flare Slope LT (%) | N/A |
| No | Ramp Cross Slope (%) | 5.2 | N/A | Flare Traversable LT | N/A |

Remove & Replace Curb Ramp With Two New Directional Ramps or Equivalent.
