# Access Compliance Report Public Rights-of-Way (Curb Ramps)

Main Street: CROWN\_VALLEY\_PKWY Cross Street: CECIL\_PASTURE\_RD Location: SE

ADA ID: RPRK211026121723 Ramp Type: Type 1 - Perpendicular Diagonal Initial Pass/Fail: Fail Overall Compliance: No Severity Score: 16

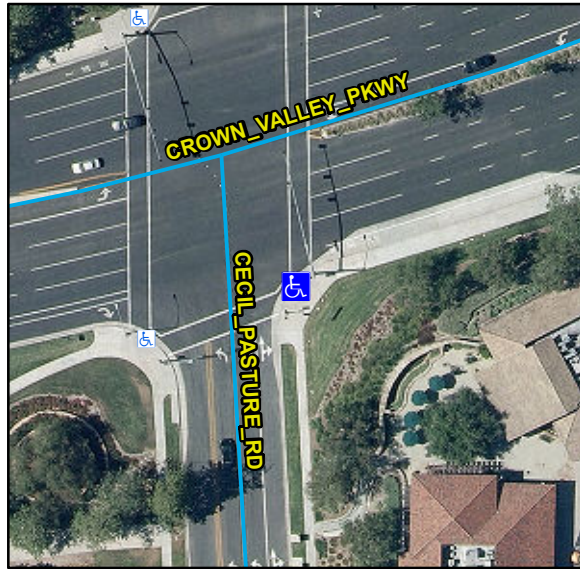
| Compliance | Description | Data | Compliance | Description | Data |
|---|---|---|---|---|---|
| No | Ramp Run Slope (%) | 9 | N/A | Flare Slope LT (%) | N/A |
| No | Ramp Cross Slope (%) | 3.3 | N/A | Flare Traversable LT | N/A |

Remove & Replace Curb Ramp With Two New Directional Ramps or Equivalent.

R304.2.2, R204.3, R304.5.3, STD 1115
