# Access Compliance Report Public Rights-of-Way (Curb Ramps)

Main Street: CECIL\_PASTURE\_RD Cross Street: N/A Location: S

ADA ID: RPRK211026122833 Ramp Type: Type 1 - Perpendicular Initial Pass/Fail: Fail Overall Compliance: No Severity Score: 15

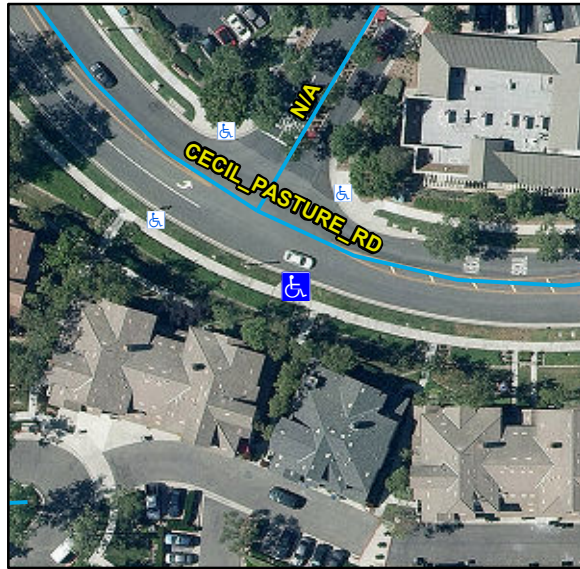
| Compliance | Description | Data | Compliance | Description | Data |
|---|---|---|---|---|---|
| No | Ramp Run Slope (%) | 9.3 | N/A | Flare Slope LT (%) | N/A |

Remove & Replace Entire Ramp.

R304.2.2, R204.3, STD 1115
