# Access Compliance Report Public Rights-of-Way (Curb Ramps)

| Main Street: CECIL_PASTURE_RD | | Cross Street: N/A | | Location: | N |
| ADA ID: RPRK211026122949 | Ramp Type: Type 4 - Parallel | Initial Pass/Fail: Fail | Overall Compliance: No | Severity Score: | 15 |

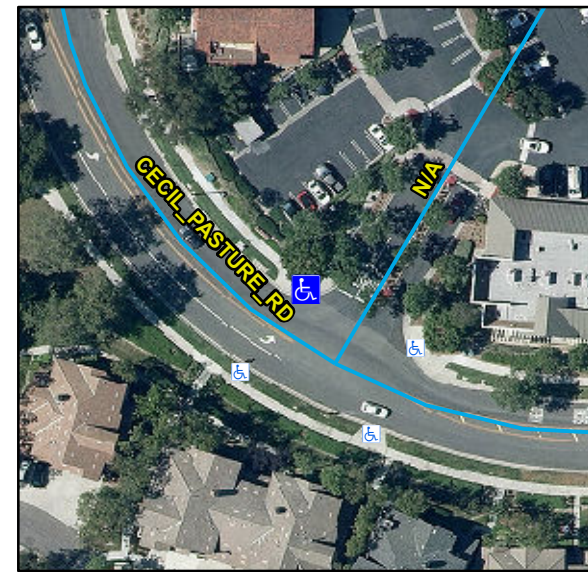
| Compliance | Description | Data | Compliance | Description | Data |
|---|---|---|---|---|---|
| No | Ramp Cross Slope LT (%) | 4.2 | No | Ramp Cross Slope RT (%) | 6.3 |

Possible Solutions:

**Remove & Replace Curb Ramp With Two New Directional Ramps or Equivalent.**

**R204.3, R304.5.3, STD 1115**

Total Cost: \$ 4000

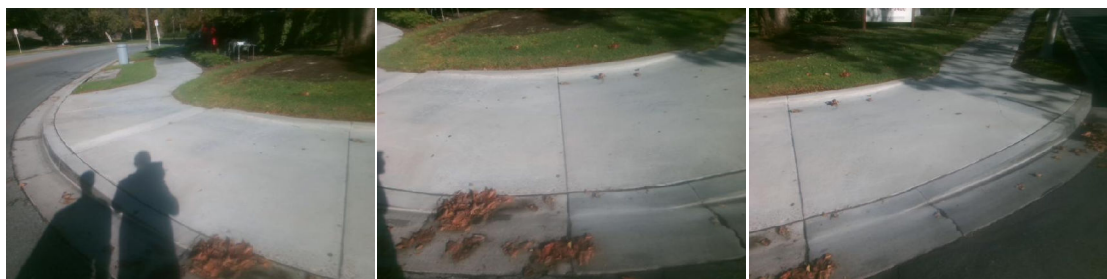
| Compliance | Description | Data | Compliance | Description | Data |
|---|---|---|---|---|---|
| N/A | Ramp Length LT (in) | 107 | N/A | Ramp Length RT (in) | 107 |
| Yes | Ramp Width LT (in) | 90 | Yes | Ramp Width RT (in) | 90 |
| Yes | Ramp Run Slope LT (%) | 1 | Yes | Ramp Run Slope RT (%) | 6.1 |
