# Access Compliance Report Public Rights-of-Way (Curb Ramps)

| Main Street: N/A | | Cross Street: CECIL_PASTURE_RD | | Location: | E |
| ADA ID: RPRK211026123204 | Ramp Type: Type 4 - Parallel | Initial Pass/Fail: Fail | Overall Compliance: No | Severity Score: | 30 |

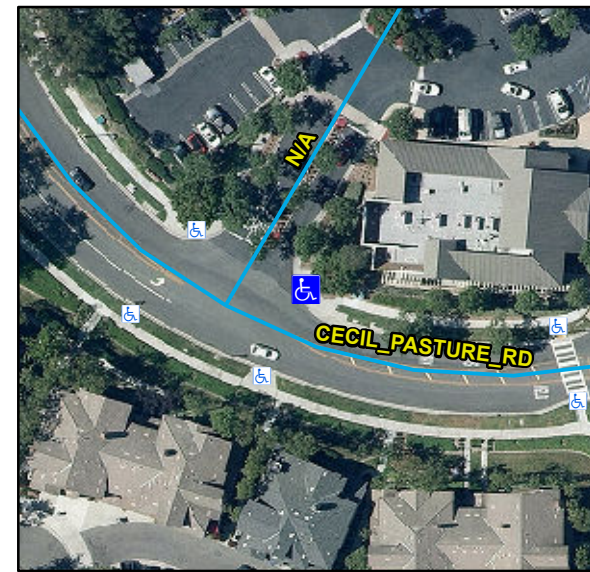
| Compliance | Description | Data | Compliance | Description | Data |
|---|---|---|---|---|---|
| Yes | Ramp Run Slope LT (%) | 1 | No | Ramp Run Slope RT (%) | 8.5 |
| No | Ramp Cross Slope LT (%) | 5.5 | Yes | Ramp Cross Slope RT (%) | 0.1 |

**Remove & Replace Curb Ramp With Two New Directional Ramps or Equivalent.**
