# Access Compliance Report Public Rights-of-Way (Curb Ramps)

Main Street: CECIL\_PASTURE\_RD Cross Street: WESTCOTT\_LN Location: NE

ADA ID: RPRK211026124957 Ramp Type: Type 4 - Parallel Initial Pass/Fail: Fail Overall Compliance: No Severity Score: 2

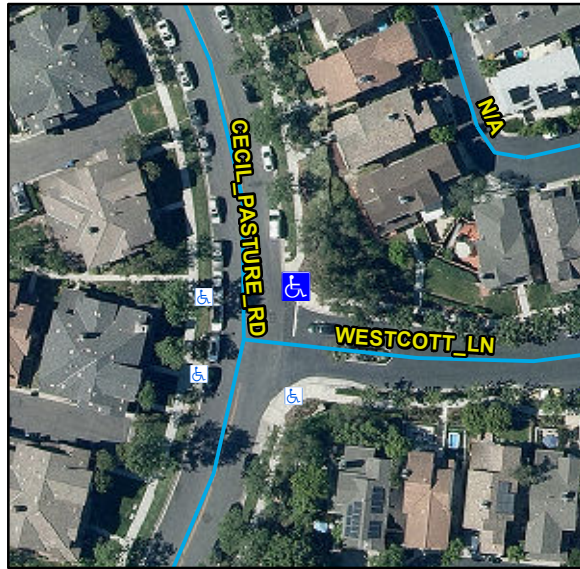
| Compliance | Description | Data | Compliance | Description | Data |
|---|---|---|---|---|---|
| Yes | Ramp Run Slope LT (%) | 2.9 | Yes | Ramp Run Slope RT (%) | 8.1 |
| No | Ramp Cross Slope LT (%) | 2.1 | No | Ramp Cross Slope RT (%) | 3.2 |

Remove & Replace Curb Ramp With Two New Directional Ramps or Equivalent.

R204.3, R304.5.3, STD 1115
