# Access Compliance Report Public Rights-of-Way (Curb Ramps)

Main Street: CECIL\_PASTURE\_RD Cross Street: WESTCOTT\_LN Location: SW

ADA ID: RPRK211026125203 Ramp Type: Type 1 - Perpendicular Initial Pass/Fail: Fail Overall Compliance: No Severity Score: 15

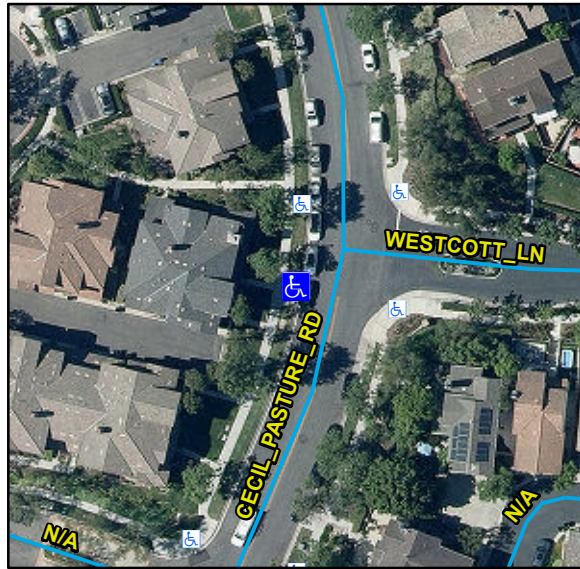
| Compliance | Description | Data | Compliance | Description | Data |
|---|---|---|---|---|---|
| No | Ramp Run Slope (%) | 8.5 | N/A | Flare Slope LT (%) | N/A |

Remove & Replace Entire Ramp.

R204.3, R304.2.2, STD 1115
