Access Compliance Report Public Rights-of-Way (Curb Ramps)

Main Street: WESTCOTT_LN **Cross Street:** CECIL_PASTURE_RD **Location:** S

ADA ID: RPRK211026125311 **Ramp Type:** Type 4 - Parallel **Initial Pass/Fail:** Fail **Overall Compliance:** No **Severity Score:** 2

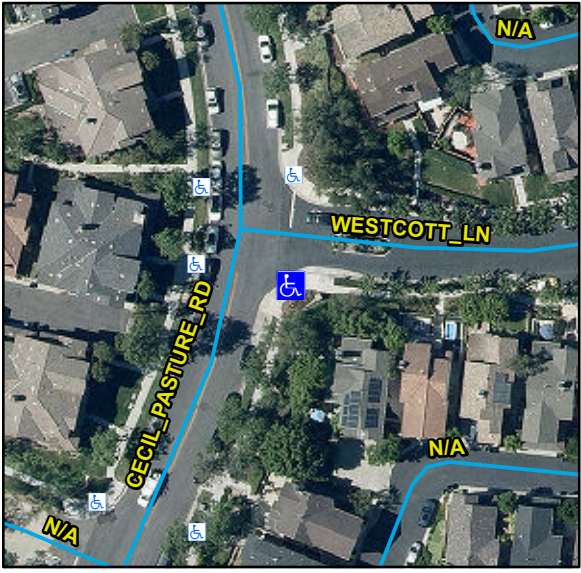
| Compliance | Description | Data | Compliance | Description | Data |
|---|---|---|---|---|---|
| No | Ramp Cross Slope LT (%) | 3.3 | No | Ramp Cross Slope RT (%) | 2.8 |

Possible Solutions:
Remove & Replace Curb Ramp With Two New Directional Ramps or Equivalent.

OC Std/PROW:
 R204.3, R304.5.3, STD 1115

Total Cost: \$ 4000
