# Access Compliance Report Public Rights-of-Way (Curb Ramps)

Main Street: WESTCOTT\_LN Cross Street: LIVINGSTON\_PL Location: NW

ADA ID: RPRK211026125549 Ramp Type: Type 4 - Parallel Initial Pass/Fail: Fail Overall Compliance: No Severity Score: 2

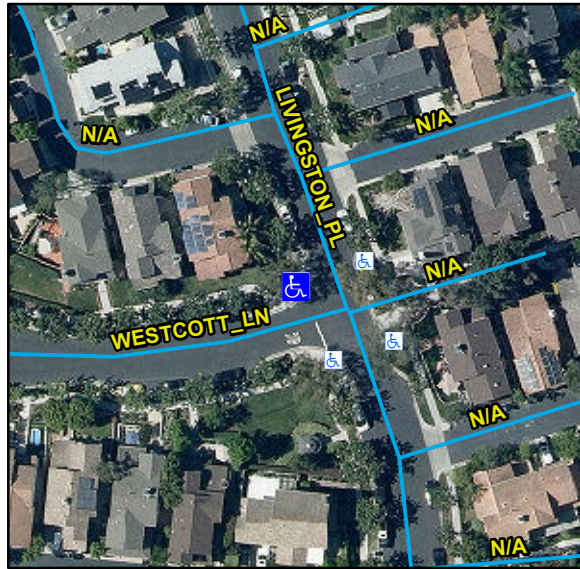
| Compliance | Description | Data | Compliance | Description | Data |
|---|---|---|---|---|---|
| Yes | Ramp Cross Slope LT (%) | 0.6 | No | Ramp Cross Slope RT (%) | 2.4 |

Remove & Replace Curb Ramp With Two New Directional Ramps or Equivalent.

R204.3, R304.5.3, STD 1115
