# Access Compliance Report Public Rights-of-Way (Curb Ramps)

Main Street: LIVINGSTON\_PL Cross Street: WESTCOTT\_LN Location: SW

ADA ID: RPRK211026130026 Ramp Type: Type 4 - Parallel Initial Pass/Fail: Fail Overall Compliance: No Severity Score: 15

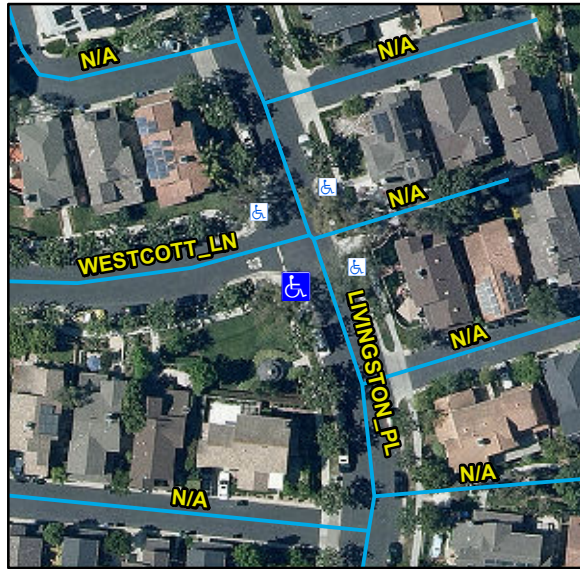
| Compliance | Description | Data | Compliance | Description | Data |
|---|---|---|---|---|---|
| No | Ramp Run Slope LT (%) | 9.7 | Yes | Ramp Run Slope RT (%) | 2.6 |
| N/A | Gutter Cross Slope (%) | N/A | No | Perpendicular Joint Present | No |

Remove & Replace Curb Ramp With Two New Directional Ramps or Equivalent.

R204.3, R304.3.2, STD 1115

Total Cost: \$ 4000
