# Access Compliance Report Public Rights-of-Way (Curb Ramps)

| Main Street: N/A | | Cross Street: CECIL_PASTURE_RD | | Location: | N |
| ADA ID: RPRK211026130417 | Ramp Type: Type 4 - Parallel | Initial Pass/Fail: Fail | Overall Compliance: No | Severity Score: | 15 |

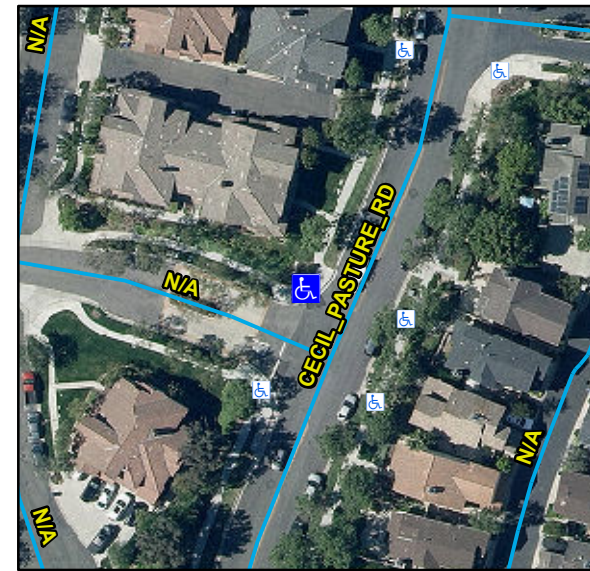
| Compliance | Description | Data | Compliance | Description | Data |
|---|---|---|---|---|---|
| No | Ramp Run Slope LT (%) | 9.5 | Yes | Ramp Run Slope RT (%) | 2.7 |

**Remove & Replace Curb Ramp With Two New Directional Ramps or Equivalent.**

**R204.3, R304.3.2, STD 1115**
