# Access Compliance Report Public Rights-of-Way (Curb Ramps)

Main Street: CECIL\_PASTURE\_RD Cross Street: N/A Location: W

ADA ID: RPRK211026130638 Ramp Type: Type 4 - Parallel Initial Pass/Fail: Fail Overall Compliance: No Severity Score: 16

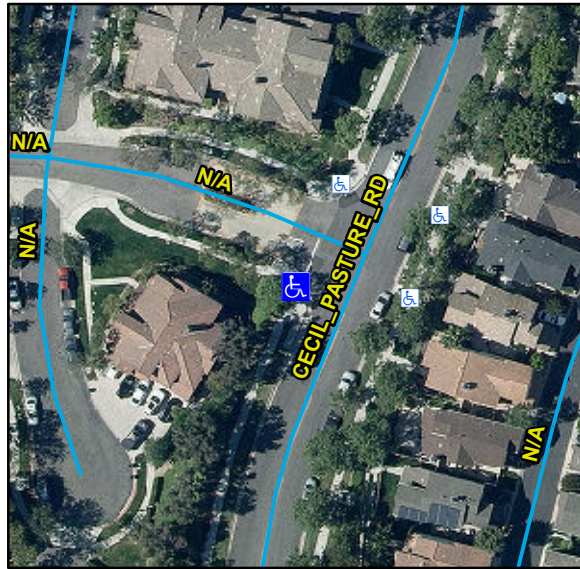
| Compliance | Description | Data | Compliance | Description | Data |
|---|---|---|---|---|---|
| No | Ramp Run Slope LT (%) | 10.4 | Yes | Ramp Run Slope RT (%) | 0 |
| No | Ramp Cross Slope LT (%) | 2.8 | No | Ramp Cross Slope RT (%) | 2.3 |

Remove & Replace Curb Ramp With Two New Directional Ramps or Equivalent.

R204.3, R304.3.2, R304.5.3, STD 1115

Total Cost: \$ 4000
