# Access Compliance Report Public Rights-of-Way (Curb Ramps)

| Main Street: DORRANCE_DR | | Cross Street: O_NEILL_DR | | Location: | NW |
| ADA ID: RPRK211026132949 | Ramp Type: Type 1 - Perpendicular | Initial Pass/Fail: Fail | Overall Compliance: No | Severity Score: | 16 |

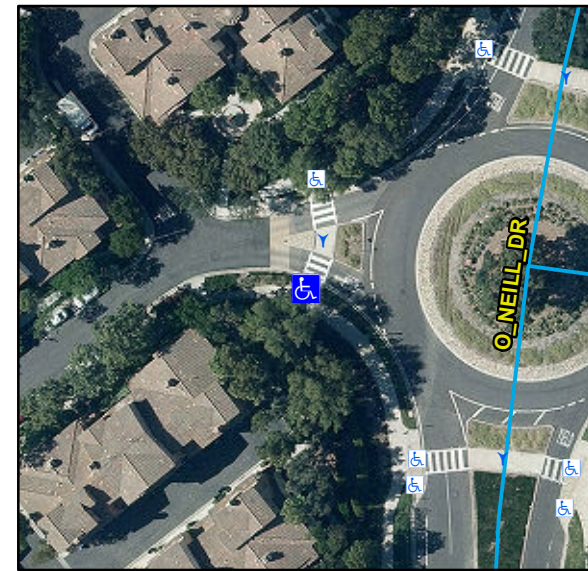
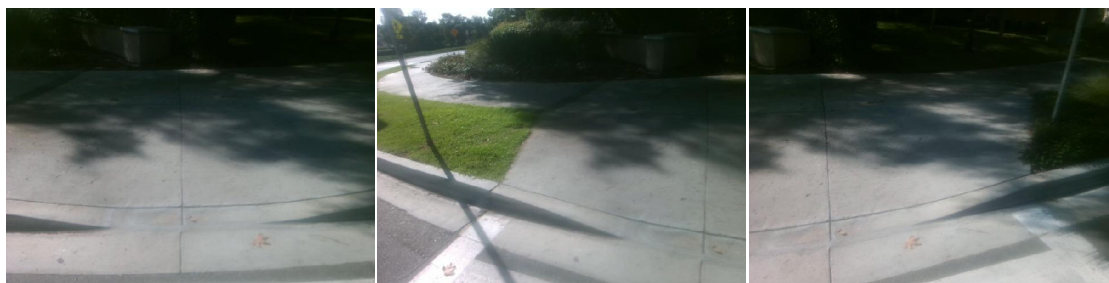
| Compliance | Description | Data | Compliance | Description | Data |
|---|---|---|---|---|---|
| No | Ramp Run Slope (%) | 8.5 | N/A | Flare Slope LT (%) | N/A |
| No | Ramp Cross Slope (%) | 4.1 | N/A | Flare Traversable LT | N/A |

**Remove & Replace Entire Ramp.**

**R304.2.2, R204.3, R304.5.3, STD 1115**
