# Access Compliance Report Public Rights-of-Way (Curb Ramps)

| Main Street: DORRANCE_DR | | Cross Street: O_NEILL_DR | | Location: | W |
| ADA ID: RPRK211026133137 | Ramp Type:Type 1 - Perpendicular | Initial Pass/Fail: Fail | Overall Compliance: No | Severity Score: | 16 |

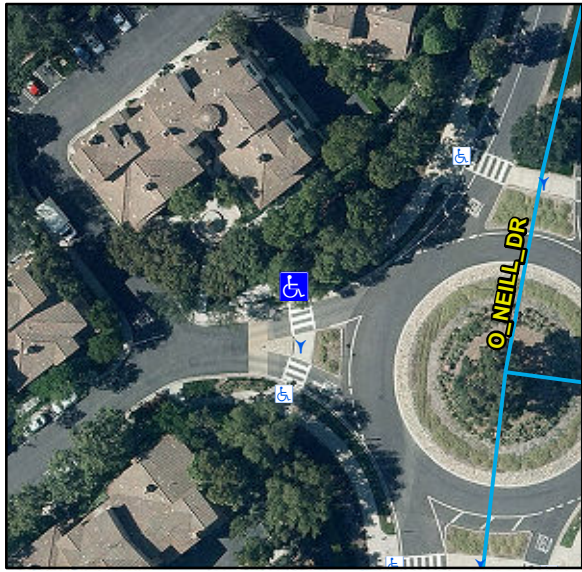
| | | | | <b>No</b> | | Ramp Run Slope (%) | | <b>10.8</b> | | <b>N/A</b> | | Flare Slope LT (%) | | <b>N/A</b> | | | | | |
| | | | | <b>No</b> | | Ramp Cross Slope (%) | | <b>4.5</b> | | <b>N/A</b> | | Flare Traversable LT | | <b>N/A</b> | | | | | |
| | | | | <b>N/A</b> | | Gutter Ponding | | <b>N/A</b> | | <b>No</b> | | Curb Slope | | <b>12.4</b> | | | | | |

| | | <b>Remove &amp; Replace Entire Ramp.</b> | | <b>N/A</b> | | Ramp Length (in) | | <b>75</b> | | <b>N/A</b> | | Flare Type LT | | <b>N/A</b> | | | | | |
