# Access Compliance Report Public Rights-of-Way (Curb Ramps)

Main Street: O\_NEILL\_DR Cross Street: DORRANCE\_DR Location: N

ADA ID: RPRK211026133259 Ramp Type: Type 4 - Parallel Initial Pass/Fail: Pass Overall Compliance: No Severity Score: 20

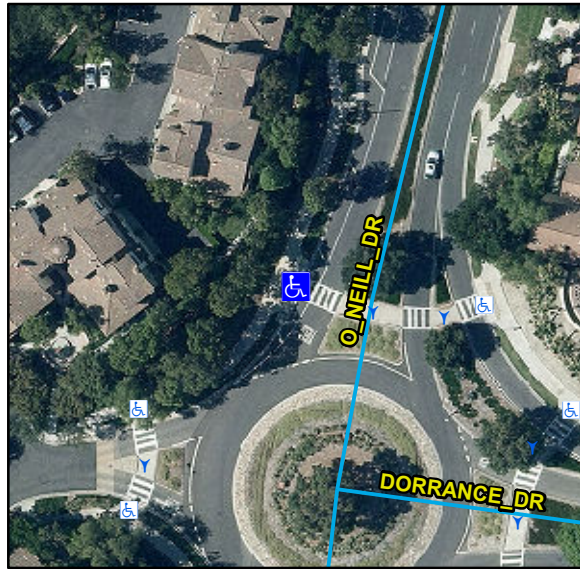
| Compliance | Description | Data | Compliance | Description | Data |
|---|---|---|---|---|---|
| N/A | Landing Present | No | No | DWS Provided | No |
| No | Landing Width (in) | N/A | N/A | DWS Length (in) | N/A |
| No | Landing Run Slope (%) | N/A | N/A | DWS Full Width | N/A |
| No | Landing Cross Slope (%) | N/A | | DWS Offset Type | N/A |
| Yes | Gutter Ponding | No | No | Curb Slope | 10 |

Possible Solutions:

Remove & Replace Entire Ramp.
