# Access Compliance Report Public Rights-of-Way (Curb Ramps)

| Main Street: DORRANCE_DR | | Cross Street: O_NEILL_DR | | Location: | NE |
| ADA ID: RPRK211026133819 | Ramp Type:Type 1 - Perpendicular | Initial Pass/Fail: Fail | Overall Compliance: No | Severity Score: | 32 |

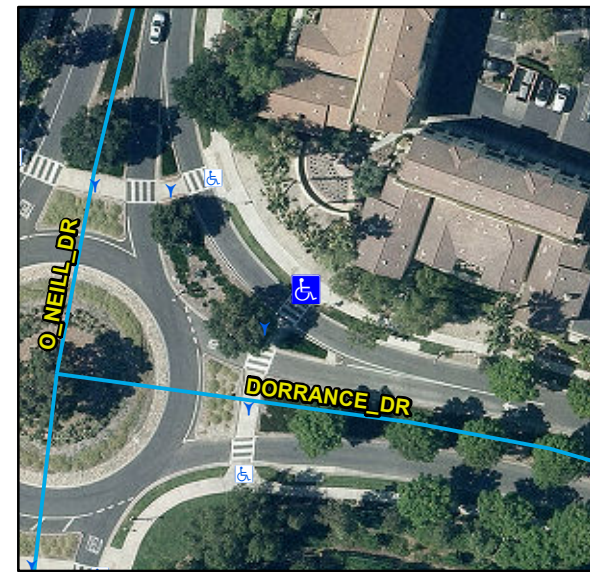
R304.2.2, R204.3, R304.5.3, STD 1115

| Compliance | Description | Data | Compliance | Description | Data |
|---|---|---|---|---|---|
| No | Ramp Run Slope (%) | 13.3 | N/A | Flare Slope LT (%) | N/A |
| No | Ramp Cross Slope (%) | 2.3 | N/A | Flare Traversable LT | N/A |

Remove & Replace Entire Ramp.

Total Cost: \$ 3080
