# Access Compliance Report Public Rights-of-Way (Curb Ramps)

| Main Street: DORRANCE_DR | | Cross Street: O_NEILL_DR | | Location: | S |
| ADA ID: RPRK211026134019 | Ramp Type: Type 1 - Perpendicular | Initial Pass/Fail: Fail | Overall Compliance: No | Severity Score: | 15 |

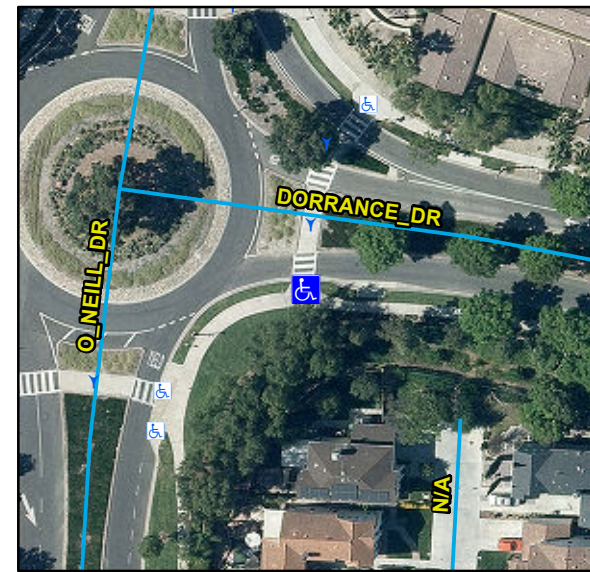
R304.2.2, R204.3, STD 1115

| Compliance | Description | Data | Compliance | Description | Data |
|---|---|---|---|---|---|
| No | Ramp Run Slope (%) | 9.1 | N/A | Flare Slope LT (%) | N/A |

Possible Solutions:

Remove & Replace Entire Ramp.

Total Cost: \$ 3080

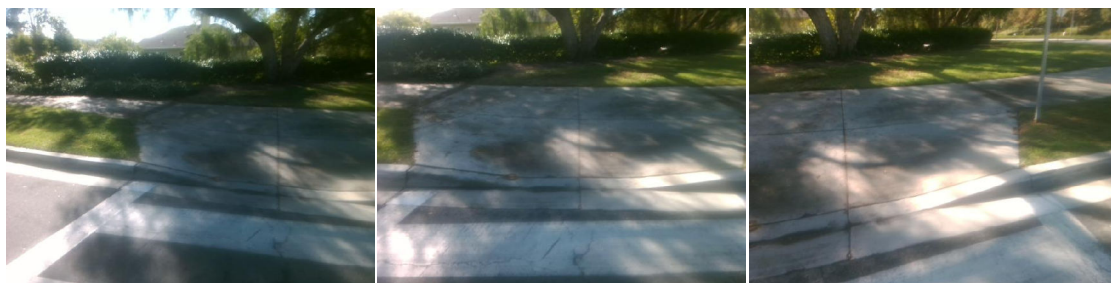
| Compliance | Description | Data | Compliance | Description | Data |
|---|---|---|---|---|---|
| N/A | Ramp Length (in) | 70 | N/A | Flare Type LT | |
| Yes | Ramp Width (in) | 48 | | | N/A |
| Yes | Ramp Cross Slope (%) | 0.9 | N/A | Flare Traversable LT | N/A |
