# Access Compliance Report Public Rights-of-Way (Curb Ramps)

Main Street: HANCEFORD\_RD Cross Street: UNIVERSITY\_AVE Location: NW

ADA ID: RPRK211026135040 Ramp Type: Type 4 - Parallel Initial Pass/Fail: Fail Overall Compliance: No Severity Score: 2

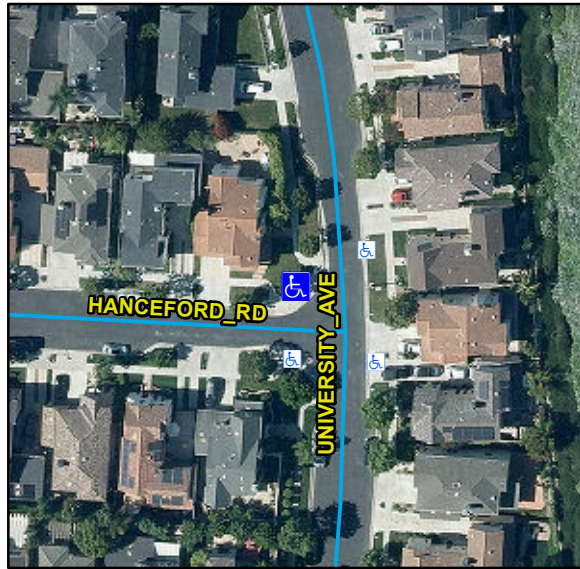
| Compliance | Description | Data | Compliance | Description | Data |
|---|---|---|---|---|---|
| Yes | Ramp Run Slope LT (%) | 3.3 | Yes | Ramp Run Slope RT (%) | 8.1 |
| No | Ramp Cross Slope LT (%) | 3.2 | No | Ramp Cross Slope RT (%) | 3.5 |

**Remove & Replace Curb Ramp With Two New Directional Ramps or Equivalent.**

**R204.3, R304.5.3, STD 1115**
