# Access Compliance Report Public Rights-of-Way (Curb Ramps)

Main Street: LONGFIELD\_LN Cross Street: HANCEFORD\_RD Location: NE

ADA ID: RPRK211026135238 Ramp Type: Type 4 - Parallel Initial Pass/Fail: Pass Overall Compliance: No Severity Score: 20

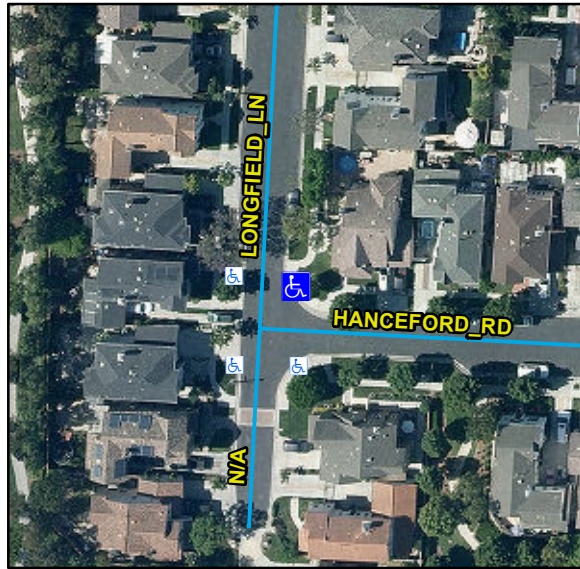
| Compliance | Description | Data | Compliance | Description | Data |
|---|---|---|---|---|---|
| N/A | Landing Present | No | No | DWS Provided | No |
| No | Landing Width (in) | N/A | N/A | DWS Length (in) | N/A |
| No | Landing Run Slope (%) | N/A | N/A | DWS Full Width | N/A |
| No | Landing Cross Slope (%) | N/A | | DWS Offset Type | N/A |
| No | Gutter Cross Slope (%) | 4.1 | No | Perpendicular Joint Present | No |

**Remove & Replace Curb Ramp With Two New Directional Ramps or Equivalent. Remove & Replace Gutter.**

**R204.3, R304.2.1, R304.2.2-Perp, R304.3.2-Para, R304.5.3, R305, STD 1115**
