# Access Compliance Report Public Rights-of-Way (Curb Ramps)

Main Street: HANCEFORD\_RD Cross Street: LONGFIELD\_LN Location: S

ADA ID: RPRK211026135724 Ramp Type: Type 4 - Parallel Initial Pass/Fail: Fail Overall Compliance: No Severity Score: 2

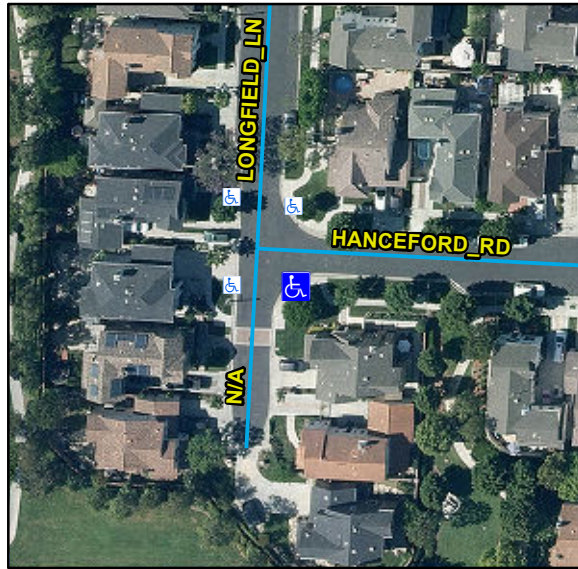
| Compliance | Description | Data | Compliance | Description | Data |
|---|---|---|---|---|---|
| Yes | Ramp Cross Slope LT (%) | 1.6 | No | Ramp Cross Slope RT (%) | 3.2 |

**Remove & Replace Curb Ramp With Two New Directional Ramps or Equivalent.**

**R204.3, R304.5.3, STD 1115**
