# Access Compliance Report Public Rights-of-Way (Curb Ramps)

Main Street: UNIVERSITY\_AVE Cross Street: HANCEFORD\_RD Location: W

ADA ID: RPRK211026135931 Ramp Type: Type 4 - Parallel Initial Pass/Fail: Pass Overall Compliance: No Severity Score: 25

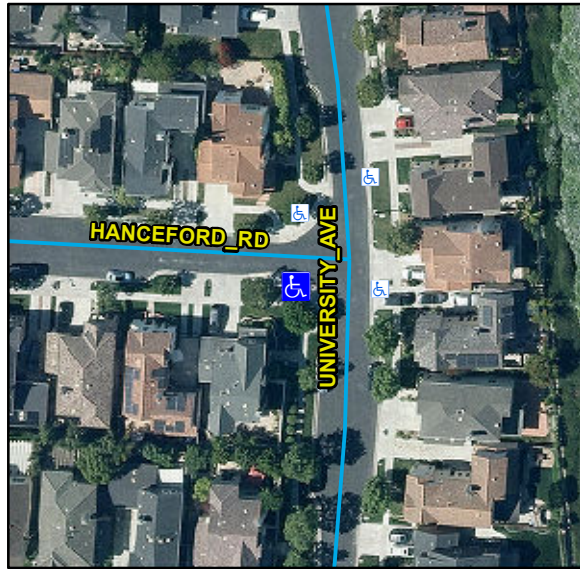
| Compliance | Description | Data | Compliance | Description | Data |
|---|---|---|---|---|---|
| N/A | Landing Present | No | No | DWS Provided | No |
| No | Landing Width (in) | N/A | N/A | DWS Length (in) | N/A |
| No | Landing Run Slope (%) | N/A | N/A | DWS Full Width | N/A |
| No | Landing Cross Slope (%) | N/A | | DWS Offset Type | N/A |
| No | Gutter Run Slope (%) | 11.7 | | Road Cross Slope (%) | 0.6 |
| Yes | Gutter Cross Slope (%) | 0.3 | No | Perpendicular Joint Present | No |

**Remove & Replace Curb Ramp With Two New Directional Ramps or Equivalent. Remove & Replace Gutter.**

**R204.3, R304.2.1, R304.2.2-Perp, R304.3.2-Para, R304.5.3, R305, R304.5.4, STD 1115**

Total Cost: \$ 4252
