# Access Compliance Report Public Rights-of-Way (Curb Ramps)

Main Street: CREIGHTON\_DR Cross Street: UNIVERSITY\_AVE Location: N

ADA ID: RPRK211026140430 Ramp Type: Type 4 - Parallel Initial Pass/Fail: Fail Overall Compliance: No Severity Score: 2

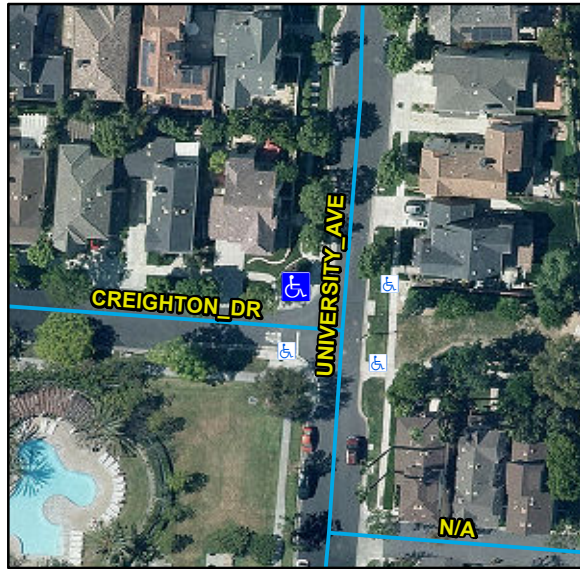
| Compliance | Description | Data | Compliance | Description | Data |
|---|---|---|---|---|---|
| No | Ramp Cross Slope LT (%) | 3.2 | No | Ramp Cross Slope RT (%) | 2.3 |
| N/A | Gutter Cross Slope (%) | N/A | No | Perpendicular Joint Present | No |

**Remove & Replace Curb Ramp With Two New Directional Ramps or Equivalent.**

**R204.3, R304.5.3, STD 1115**

Total Cost: \$ 4000
