# Access Compliance Report Public Rights-of-Way (Curb Ramps)

Main Street: UNIVERSITY\_AVE Cross Street: CREIGHTON\_DR Location: SW

ADA ID: RPRK211026140645 Ramp Type: Type 4 - Parallel Initial Pass/Fail: Pass Overall Compliance: No Severity Score: 25

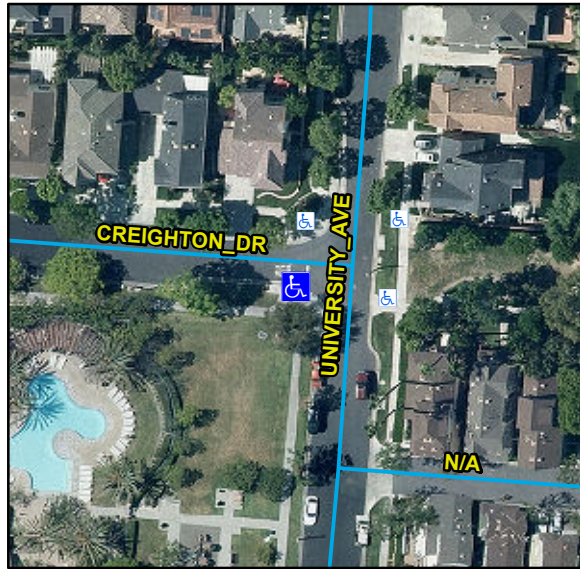
| Compliance | Description | Data | Compliance | Description | Data |
|---|---|---|---|---|---|
| N/A | Landing Present | No | No | DWS Provided | No |
| No | Landing Width (in) | N/A | N/A | DWS Length (in) | N/A |
| No | Landing Run Slope (%) | N/A | N/A | DWS Full Width | N/A |
| No | Landing Cross Slope (%) | N/A | | DWS Offset Type | N/A |
| Yes | Gutter Ponding | No | No | Curb Slope | 13.7 |
| No | Gutter Run Slope (%) | 5.1 | | Road Cross Slope (%) | 3.6 |

Remove & Replace Curb Ramp With Two New Directional Ramps or Equivalent. Remove & Replace Gutter.
