# Access Compliance Report Public Rights-of-Way (Curb Ramps)

Main Street: CREIGHTON\_DR Cross Street: CREIGHTON\_DR Location: NW

ADA ID: RPRK211026141541 Ramp Type: Type 1 - Perpendicular Initial Pass/Fail: Fail Overall Compliance: No Severity Score: 16

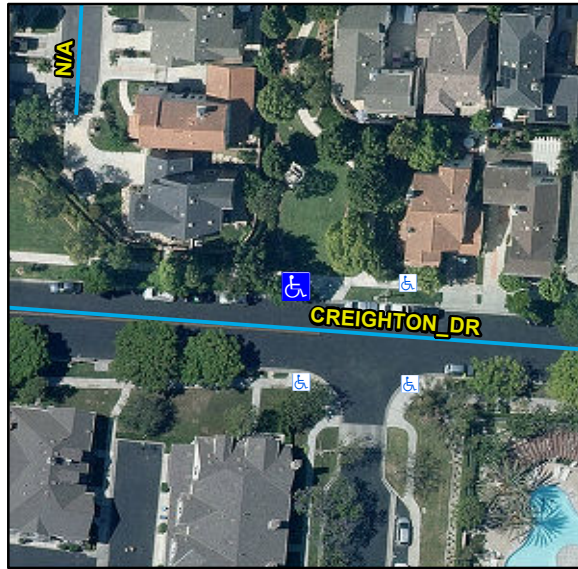
| Compliance | Description | Data | Compliance | Description | Data |
|---|---|---|---|---|---|
| No | Ramp Run Slope (%) | 11.2 | N/A | Flare Slope LT (%) | N/A |
| N/A | Gutter Ponding | N/A | No | Curb Slope | 10.1 |

Remove & Replace Entire Ramp.

R304.2.2, R204.3, STD 1115
