# Access Compliance Report Public Rights-of-Way (Curb Ramps)

Main Street: N/A Cross Street: CREIGHTON\_DR Location: S

ADA ID: RPRK211026141720 Ramp Type: Type 4 - Parallel Initial Pass/Fail: Fail Overall Compliance: No Severity Score: 2

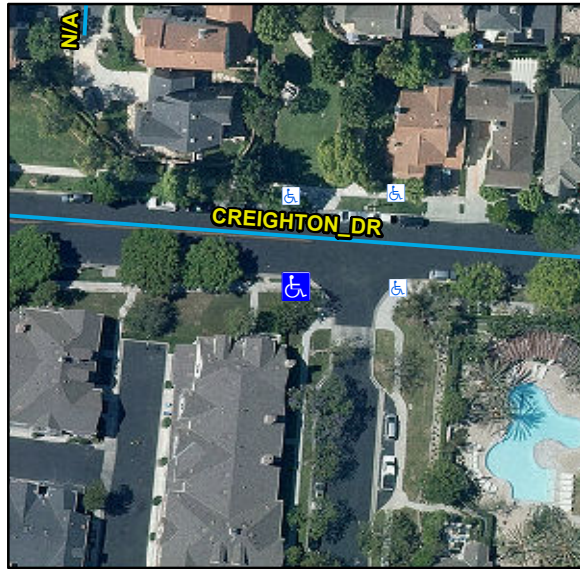
| Compliance | Description | Data | Compliance | Description | Data |
|---|---|---|---|---|---|
| No | Ramp Cross Slope LT (%) | 3.2 | Yes | Ramp Cross Slope RT (%) | 0.4 |
| N/A | Gutter Ponding | N/A | No | Curb Slope | 16.8 |

**Remove & Replace Curb Ramp With Two New Directional Ramps or Equivalent.**

**R304.2.2, R204.3, R304.5.3, STD 1115**

Total Cost: \$ 4000
