# Access Compliance Report Public Rights-of-Way (Curb Ramps)

Main Street: O\_NEILL\_DR Cross Street: CREIGHTON\_DR Location: E

ADA ID: RPRK211026142345 Ramp Type: Type 4 - Parallel Initial Pass/Fail: Fail Overall Compliance: No Severity Score: 15

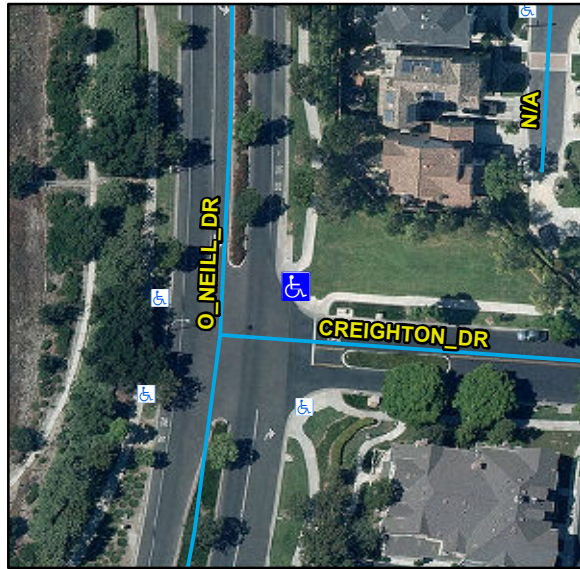
| Compliance | Description | Data | Compliance | Description | Data |
|---|---|---|---|---|---|
| No | Ramp Run Slope LT (%) | 10.1 | Yes | Ramp Run Slope RT (%) | 1 |
| N/A | Gutter Cross Slope (%) | N/A | No | Perpendicular Joint Present | No |

Remove & Replace Curb Ramp With Two New Directional Ramps or Equivalent.

R204.3, R304.3.2, STD 1115

Total Cost: \$ 4000
