# Access Compliance Report Public Rights-of-Way (Curb Ramps)

Main Street: ETON\_PL Cross Street: ETON\_PL Location: NW

ADA ID: RPRK211026143519 Ramp Type: Type 4 - Parallel Initial Pass/Fail: Pass Overall Compliance: No Severity Score: 25

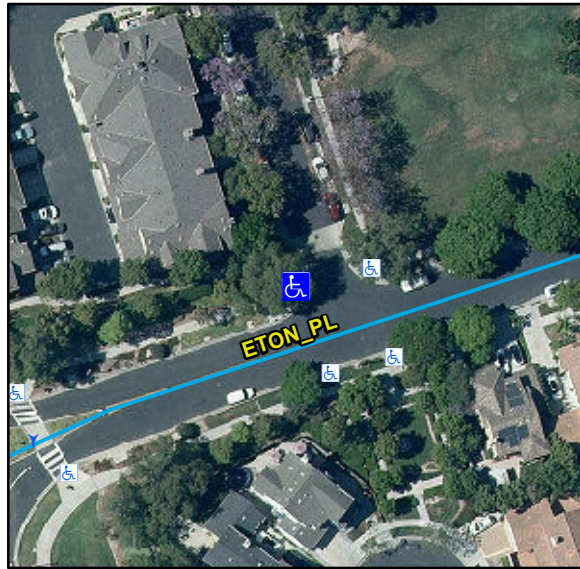
| Compliance | Description | Data | Compliance | Description | Data |
|---|---|---|---|---|---|
| N/A | Landing Present | No | No | DWS Provided | No |
| No | Landing Width (in) | N/A | N/A | DWS Length (in) | N/A |
| No | Gutter Run Slope (%) | 6.4 | | Road Cross Slope (%) | 7 |
| No | Gutter Cross Slope (%) | 3.1 | No | Perpendicular Joint Present | No |

Remove & Replace Curb Ramp With Two New Directional Ramps or Equivalent. Remove & Replace Gutter.
