# Access Compliance Report Public Rights-of-Way (Curb Ramps)

Main Street: ETON\_PL Cross Street: ETON\_PL Location: NE

ADA ID: RPRK211026143800 Ramp Type: Type 4 - Parallel Initial Pass/Fail: Fail Overall Compliance: No Severity Score: 2

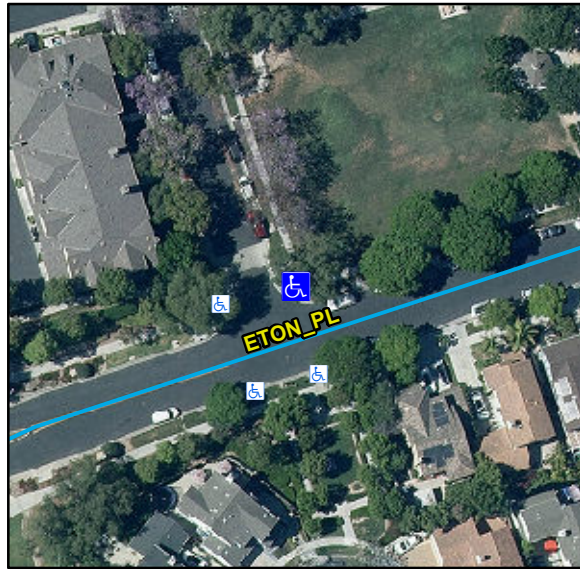
| Compliance | Description | Data | Compliance | Description | Data |
|---|---|---|---|---|---|
| No | Ramp Cross Slope LT (%) | 2.9 | No | Ramp Cross Slope RT (%) | 2.4 |

**Remove & Replace Curb Ramp With Two New Directional Ramps or Equivalent.**

**R204.3, R304.5.3, STD 1115**
