# Access Compliance Report Public Rights-of-Way (Curb Ramps)

Main Street: ETON\_PL Cross Street: UNIVERSITY\_AVE Location: NW

ADA ID: RPRK211026144236 Ramp Type: Type 4 - Parallel Initial Pass/Fail: Fail Overall Compliance: No Severity Score: 2

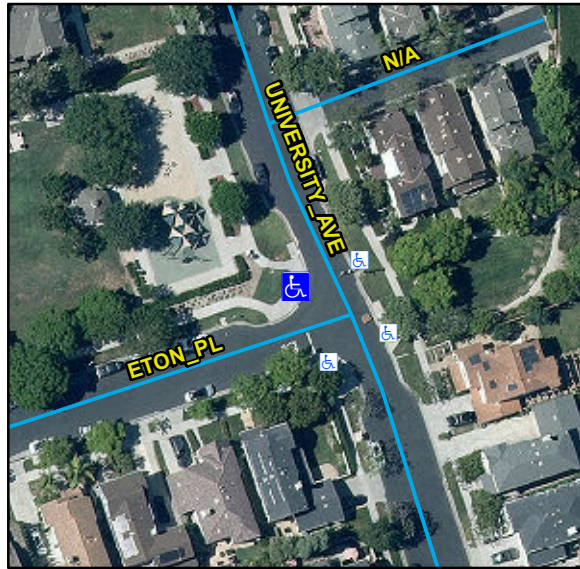
| Compliance | Description | Data | Compliance | Description | Data |
|---|---|---|---|---|---|
| Yes | Ramp Run Slope LT (%) | 0.4 | Yes | Ramp Run Slope RT (%) | 7.9 |
| No | Ramp Cross Slope LT (%) | 2.1 | Yes | Ramp Cross Slope RT (%) | 1.9 |
| No | Gutter Lip Height (in) | 0.25 | | Road Run Slope (%) | 3 |

Remove & Replace Curb Ramp With Two New Directional Ramps or Equivalent. Grind Gutter Lip.

R204.3, R304.5.3, R302.7.2, STD 1115

Total Cost: \$ 4150
