# Access Compliance Report Public Rights-of-Way (Curb Ramps)

Main Street: UNIVERSITY\_AVE Cross Street: ETON\_PL Location: S

ADA ID: RPRK211026144541 Ramp Type: Type 1 - Perpendicular Initial Pass/Fail: Pass Overall Compliance: No Severity Score: 17

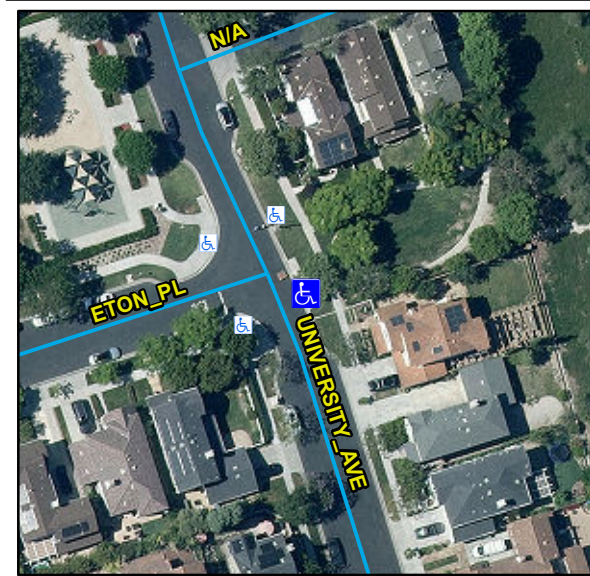
| Compliance | Description | Data | Compliance | Description | Data |
|---|---|---|---|---|---|
| No | Landing Cross Slope (%) | 2.2 | No | DWS Provided | No |
| Yes | Gutter Ponding | No | No | Curb Slope | 11.3 |
| No | Gutter Run Slope (%) | 14.1 | | Road Cross Slope (%) | N/A |
| No | Gutter Cross Slope (%) | 2.7 | | | |

Remove & Replace Entire Ramp. Remove & Replace Gutter.

R304.2.2, R304.5.3, R305, R304.5.4, STD 1115
