# Access Compliance Report Public Rights-of-Way (Curb Ramps)

Main Street: UNIVERSITY\_AVE Cross Street: ETON\_PL Location: SW

ADA ID: RPRK211026144741 Ramp Type: Type 4 - Parallel Initial Pass/Fail: Pass Overall Compliance: No Severity Score: 25

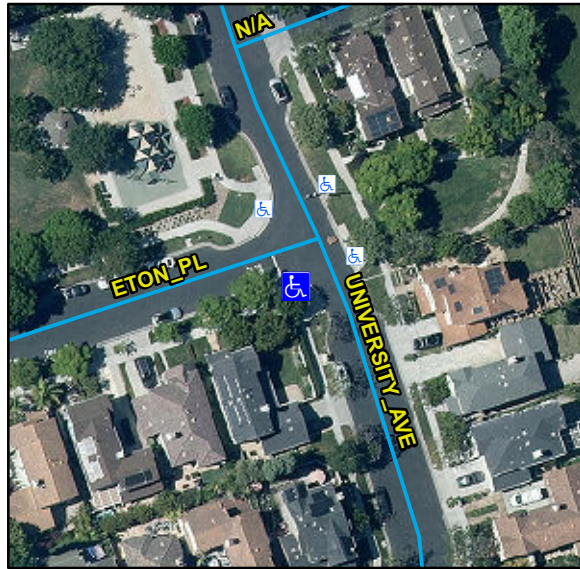
| Compliance | Description | Data | Compliance | Description | Data |
|---|---|---|---|---|---|
| N/A | Landing Present | No | No | DWS Provided | No |
| No | Landing Width (in) | N/A | N/A | DWS Length (in) | N/A |
| No | Landing Run Slope (%) | N/A | N/A | DWS Full Width | N/A |
| No | Landing Cross Slope (%) | N/A | | DWS Offset Type | N/A |
| Yes | Gutter Ponding | No | No | Curb Slope | 15.4 |
| No | Gutter Run Slope (%) | 8.7 | | Road Cross Slope (%) | 2.9 |
| No | Gutter Cross Slope (%) | 3.4 | No | Perpendicular Joint Present | No |

Remove & Replace Curb Ramp With Two New Directional Ramps or Equivalent. Remove & Replace Gutter.
