# Access Compliance Report Public Rights-of-Way (Curb Ramps)

Main Street: **SECOND\_ST** Cross Street: **MAIN\_ST** Location: **S**

ADA ID: **RPRK211026164332** Ramp Type: **Type 4 - Parallel** Initial Pass/Fail: **Pass** Overall Compliance: **No** Severity Score: **25**

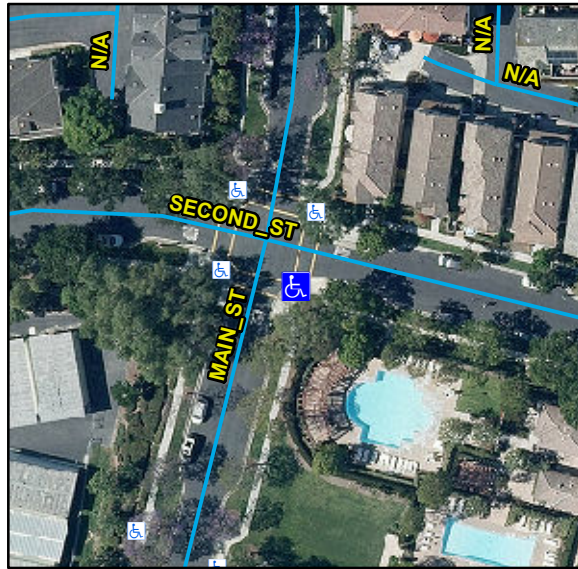
| Compliance | Description | Data | Compliance | Description | Data |
|---|---|---|---|---|---|
| <b>N/A</b> | Landing Present | <b>No</b> | <b>No</b> | DWS Provided | <b>No</b> |
| <b>No</b> | Landing Width (in) | <b>N/A</b> | <b>N/A</b> | DWS Length (in) | <b>N/A</b> |
| <b>No</b> | Landing Run Slope (%) | <b>N/A</b> | <b>N/A</b> | DWS Full Width | <b>N/A</b> |
| <b>No</b> | Landing Cross Slope (%) | <b>N/A</b> | | DWS Offset Type | <b>N/A</b> |
| <b>No</b> | Gutter Run Slope (%) | <b>11.1</b> | | Road Cross Slope (%) | <b>1.9</b> |
| <b>Yes</b> | Gutter Cross Slope (%) | <b>1.9</b> | <b>No</b> | Perpendicular Joint Present | <b>No</b> |

**Remove & Replace Curb Ramp With Two New Directional Ramps or Equivalent. Remove & Replace Gutter.**
