# Access Compliance Report Public Rights-of-Way (Curb Ramps)

Main Street: MAIN\_ST Cross Street: SECOND\_ST Location: E

ADA ID: RPRK211026165827 Ramp Type: Type 4 - Parallel Initial Pass/Fail: Fail Overall Compliance: No Severity Score: 2

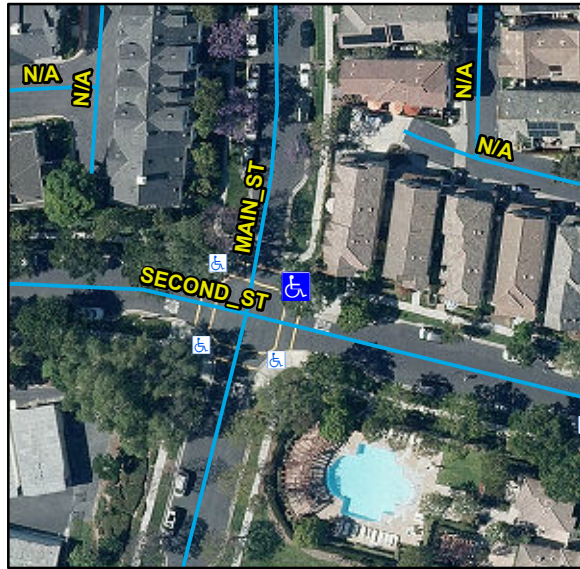
| Compliance | Description | Data | Compliance | Description | Data |
|---|---|---|---|---|---|
| No | Ramp Cross Slope LT (%) | 4.7 | No | Ramp Cross Slope RT (%) | 3.2 |

**Remove & Replace Curb Ramp With Two New Directional Ramps or Equivalent.**

**R204.3, R304.5.3, STD 1115**
