# Access Compliance Report Public Rights-of-Way (Curb Ramps)

| Main Street: <b>SECOND_ST</b> | Cross Street: <b>MAIN_ST</b> | Location: <b>N</b> |

| ADA ID: <b>RPRK211026170427</b> | Ramp Type: <b>Type 4 - Parallel</b> | Initial Pass/Fail: <b>Fail</b> | Overall Compliance: <b>No</b> | Severity Score: <b>16</b> |

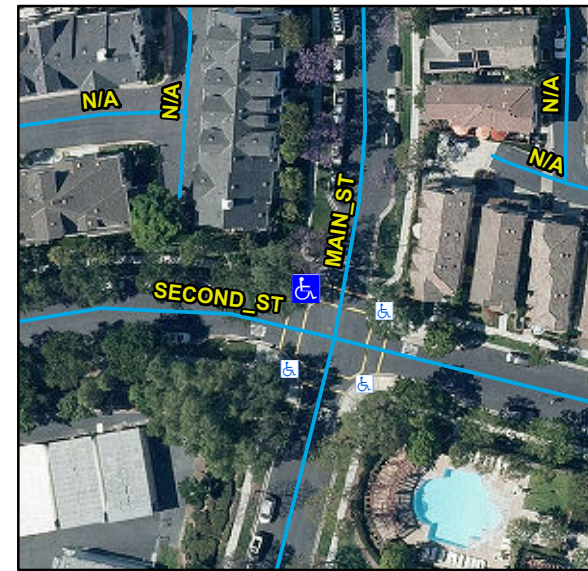
**R204.3, R304.5.3, R304.3.2, STD 1115**

| Compliance | Description | Data | Compliance | Description | Data |
|---|---|---|---|---|---|
| <b>Yes</b> | Ramp Run Slope LT (%) | <b>1.6</b> | <b>No</b> | Ramp Run Slope RT (%) | <b>9.6</b> |
| <b>No</b> | Ramp Cross Slope LT (%) | <b>2.3</b> | <b>Yes</b> | Ramp Cross Slope RT (%) | <b>1.2</b> |

**Remove & Replace Curb Ramp With Two New Directional Ramps or Equivalent.**

Total Cost: \$ **4000**

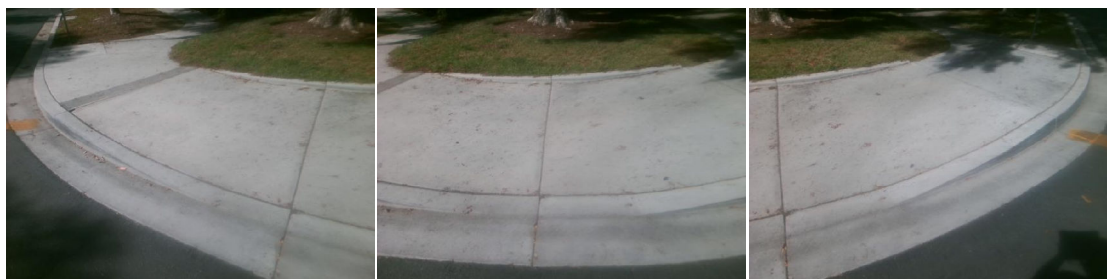
| Compliance | Description | Data | Compliance | Description | Data |
|---|---|---|---|---|---|
| <b>N/A</b> | Ramp Length LT (in) | <b>100</b> | <b>N/A</b> | Ramp Length RT (in) | <b>105</b> |
| <b>Yes</b> | Ramp Width LT (in) | <b>90</b> | <b>Yes</b> | Ramp Width RT (in) | <b>90</b> |
| <b>Yes</b> | Gutter Lip Height (in) | <b>0</b> | | Road Run Slope (%) | <b>3.7</b> |
| <b>N/A</b> | Gutter Cross Slope (%) | <b>N/A</b> | <b>No</b> | Perpendicular Joint Present | <b>No</b> |
