# Access Compliance Report Public Rights-of-Way (Curb Ramps)

Main Street: N/A Cross Street: MAIN\_ST Location: SE

ADA ID: RPRK211026171346 Ramp Type: Type 4 - Parallel Initial Pass/Fail: Fail Overall Compliance: No Severity Score: 15

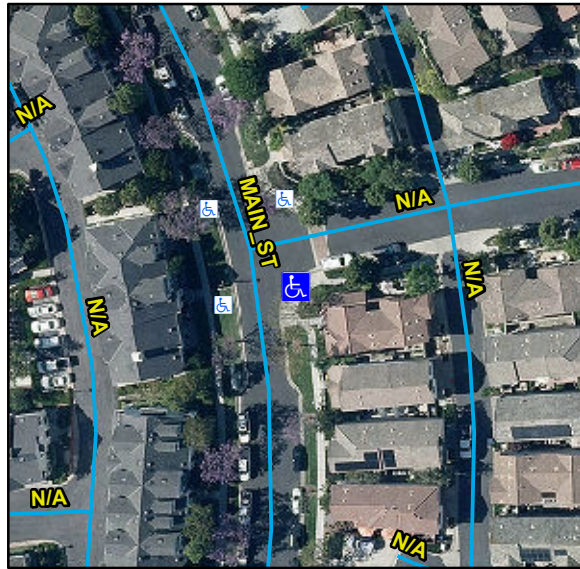
| Compliance | Description | Data | Compliance | Description | Data |
|---|---|---|---|---|---|
| No | Ramp Cross Slope LT (%) | 5.4 | Yes | Ramp Cross Slope RT (%) | 1.5 |

Remove & Replace Curb Ramp With Two New Directional Ramps or Equivalent.

R204.3, R304.5.3, STD 1115
