# Access Compliance Report Public Rights-of-Way (Curb Ramps)

Main Street: MAIN\_ST Cross Street: N/A Location: NE

ADA ID: RPRK211026171858 Ramp Type: Type 4 - Parallel Initial Pass/Fail: Fail Overall Compliance: No Severity Score: 2

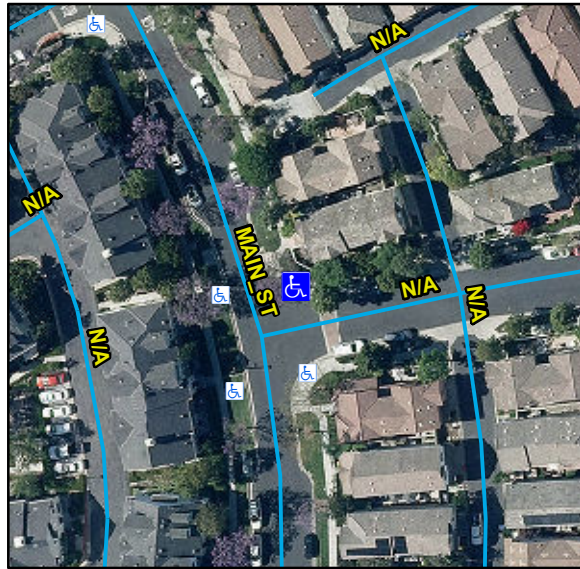
| Compliance | Description | Data | Compliance | Description | Data |
|---|---|---|---|---|---|
| Yes | Ramp Cross Slope LT (%) | 1.8 | No | Ramp Cross Slope RT (%) | 2.8 |
| N/A | Gutter Cross Slope (%) | N/A | No | Perpendicular Joint Present | No |

**Remove & Replace Curb Ramp With Two New Directional Ramps or Equivalent.**

**R204.3, R304.5.3, STD 1115**

Total Cost: \$ 4000
