# Access Compliance Report Public Rights-of-Way (Curb Ramps)

Main Street: 1ST\_ST Cross Street: MAIN\_ST Location: SE

ADA ID: RPRK211026172708 Ramp Type: Type 4 - Parallel Initial Pass/Fail: Fail Overall Compliance: No Severity Score: 2

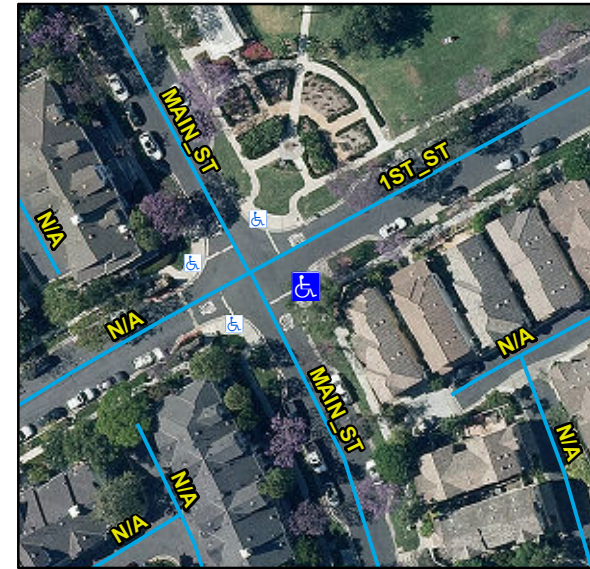
| Compliance | Description | Data | Compliance | Description | Data |
|---|---|---|---|---|---|
| Yes | Ramp Cross Slope LT (%) | 2 | No | Ramp Cross Slope RT (%) | 2.6 |

Possible Solutions:  
**Remove & Replace Curb Ramp With Two New Directional Ramps or Equivalent.**

OC Std/PROW:  
**R204.3, R304.5.3, STD 1115**

Total Cost: \$ 4000
