# Access Compliance Report Public Rights-of-Way (Curb Ramps)

Main Street: MAIN\_ST Cross Street: 1ST\_ST Location: NE

ADA ID: RPRK211026173249 Ramp Type: Type 4 - Parallel Initial Pass/Fail: Pass Overall Compliance: No Severity Score: 25

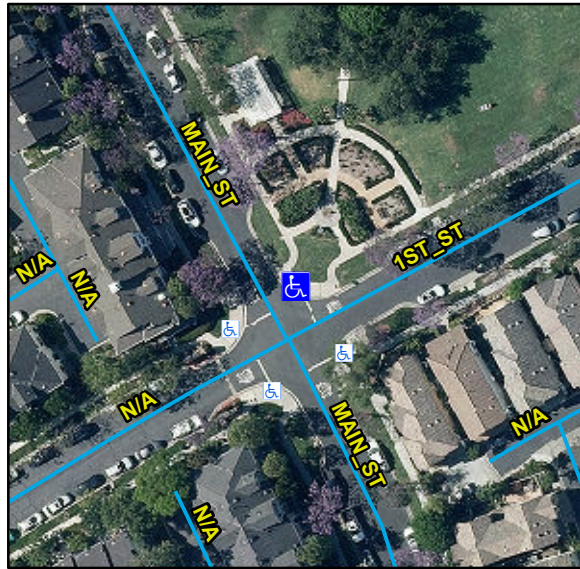
R204.3, R304.2.1, R304.2.2-Perp, R304.3.2-Para, R304.5.3, R305, R304.5.4, STD 1115

| Compliance | Description | Data | Compliance | Description | Data |
|---|---|---|---|---|---|
| N/A | Landing Present | No | No | DWS Provided | No |
| No | Landing Width (in) | N/A | N/A | DWS Length (in) | N/A |
| No | Landing Run Slope (%) | N/A | N/A | DWS Full Width | N/A |
| No | Landing Cross Slope (%) | N/A | | DWS Offset Type | N/A |
| No | Gutter Run Slope (%) | 10.6 | | Road Cross Slope (%) | 0.9 |

Remove & Replace Curb Ramp With Two New Directional Ramps or Equivalent. Remove & Replace Gutter.
