# Access Compliance Report Public Rights-of-Way (Curb Ramps)

Main Street: MAIN\_ST Cross Street: SECOND\_ST Location: SW

ADA ID: RPRK211026175404 Ramp Type: Type 4 - Parallel Initial Pass/Fail: Fail Overall Compliance: No Severity Score: 2

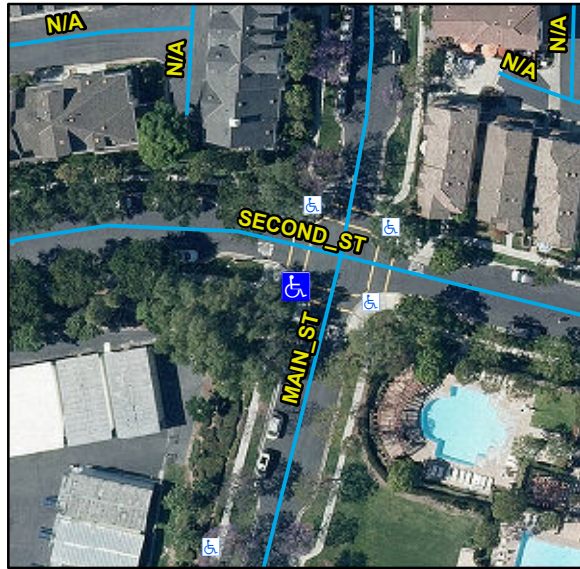
| Compliance | Description | Data | Compliance | Description | Data |
|---|---|---|---|---|---|
| Yes | Ramp Cross Slope LT (%) | 1.9 | No | Ramp Cross Slope RT (%) | 2.2 |

**Remove & Replace Curb Ramp With Two New Directional Ramps or Equivalent.**

**R204.3, R304.5.3, STD 1115**

Total Cost: \$ 4000
