# Access Compliance Report Public Rights-of-Way (Curb Ramps)

Main Street: **SECOND\_ST** Cross Street: **N/A** Location: **N**

ADA ID: **RPRK211026180141** Ramp Type: **Type 4 - Parallel** Initial Pass/Fail: **Fail** Overall Compliance: **No** Severity Score: **2**

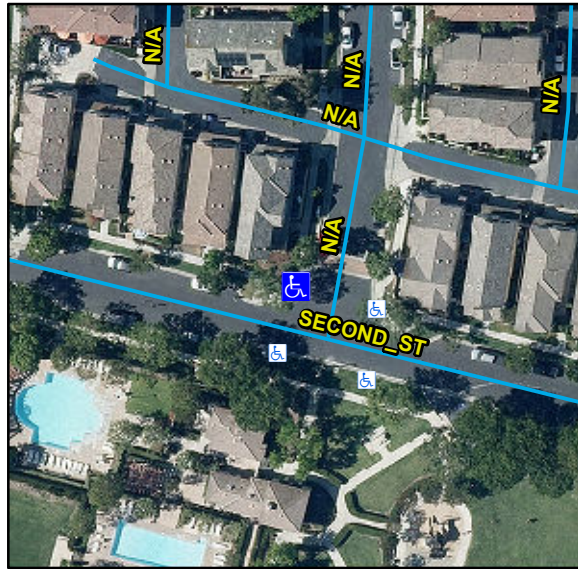
| Compliance | Description | Data | Compliance | Description | Data |
|---|---|---|---|---|---|
| <b>No</b> | Ramp Cross Slope LT (%) | <b>2.9</b> | <b>No</b> | Ramp Cross Slope RT (%) | <b>3.2</b> |

**Remove & Replace Curb Ramp With Two New Directional Ramps or Equivalent.**

**R304.5.3, STD 1115**
