# Access Compliance Report Public Rights-of-Way (Curb Ramps)

Main Street: N/A Cross Street: SECOND\_ST Location: NE

ADA ID: RPRK211026180705 Ramp Type: Type 4 - Parallel Initial Pass/Fail: Fail Overall Compliance: No Severity Score: 16

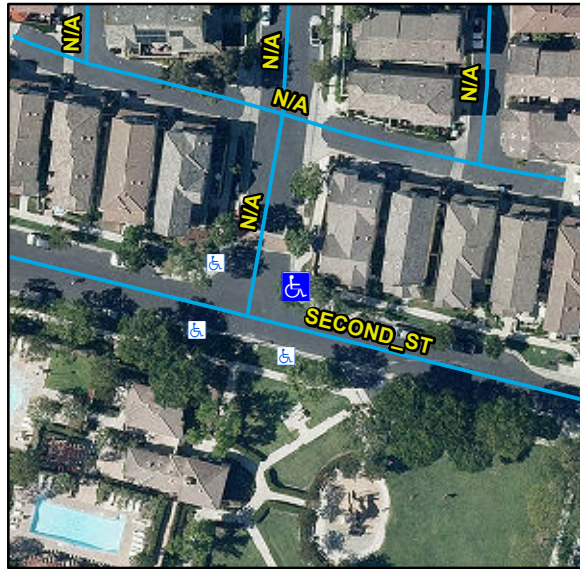
| Compliance | Description | Data | Compliance | Description | Data |
|---|---|---|---|---|---|
| Yes | Ramp Run Slope LT (%) | 0.1 | No | Ramp Run Slope RT (%) | 8.6 |
| No | Ramp Cross Slope LT (%) | 3.7 | No | Ramp Cross Slope RT (%) | 2.1 |

**Remove & Replace Curb Ramp With Two New Directional Ramps or Equivalent.**

**R304.5.3, R304.3.2, STD 1115**
