# Access Compliance Report Public Rights-of-Way (Curb Ramps)

Main Street: ELLISTON\_DR Cross Street: CERNER\_CT Location: SE

ADA ID: RPRK211027114534 Ramp Type: Type 4 - Parallel Initial Pass/Fail: Fail Overall Compliance: No Severity Score: 16

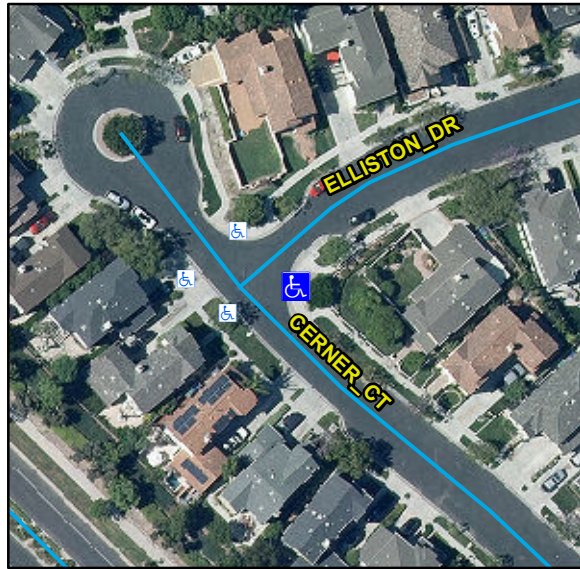
| Compliance | Description | Data | Compliance | Description | Data |
|---|---|---|---|---|---|
| Yes | Ramp Run Slope LT (%) | 0.4 | No | Ramp Run Slope RT (%) | 8.7 |
| Yes | Ramp Cross Slope LT (%) | 1.8 | No | Ramp Cross Slope RT (%) | 3.2 |

**Remove & Replace Curb Ramp With Two New Directional Ramps or Equivalent.**

**R204.3, R304.3.2, R304.5.3, STD 1115**
