# Access Compliance Report Public Rights-of-Way (Curb Ramps)

Main Street: CERNER\_CT Cross Street: ELLISTON\_DR Location: NE

ADA ID: RPRK211027114838 Ramp Type: Type 4 - Parallel Initial Pass/Fail: Pass Overall Compliance: No Severity Score: 25

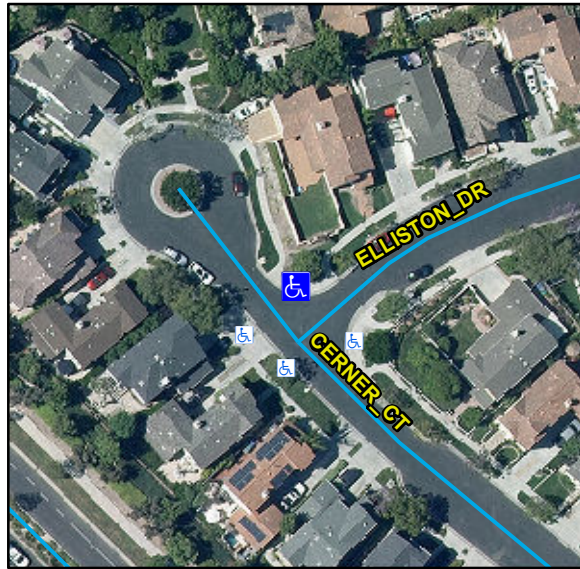
R304.2.2, R204.3, R304.2.1, R304.2.2-Perp, R304.3.2-Para, R304.5.3, R305, R302.7.2, R304.5.4, STD 1115

| Compliance | Description | Data | Compliance | Description | Data |
|---|---|---|---|---|---|
| N/A | Landing Present | No | No | DWS Provided | No |
| No | Landing Width (in) | N/A | N/A | DWS Length (in) | N/A |
| No | Landing Run Slope (%) | N/A | N/A | DWS Full Width | N/A |
| No | Landing Cross Slope (%) | N/A | | DWS Offset Type | N/A |
| Yes | Gutter Ponding | No | No | Curb Slope | 8.6 |
| No | Gutter Lip Height (in) | 0.25 | | Road Run Slope (%) | 2.1 |
| No | Gutter Run Slope (%) | 11 | | Road Cross Slope (%) | 4.3 |
| Yes | Gutter Cross Slope (%) | 0.6 | No | Perpendicular Joint Present | No |

Remove & Replace Curb Ramp With Two New Directional Ramps or Equivalent. Remove & Replace Gutter.
