# Access Compliance Report Public Rights-of-Way (Curb Ramps)

| Main Street: ETON_PL | | Cross Street: O_NEILL_DR | | Location: | E |
| ADA ID: RPRK211027115238 | Ramp Type:Type 1 - Perpendicular | Initial Pass/Fail: Fail | Overall Compliance: No | Severity Score: | 15 |

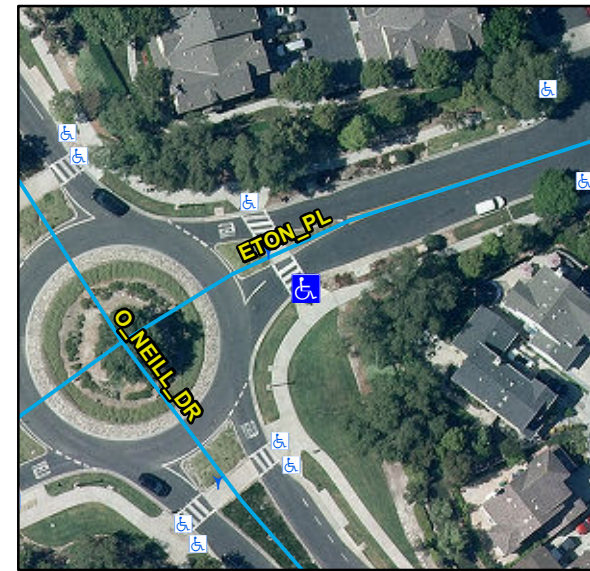
| Compliance | Description | Data | Compliance | Description | Data |
|---|---|---|---|---|---|
| No | Ramp Run Slope (%) | 8.4 | N/A | Flare Slope LT (%) | N/A |

**Remove & Replace Entire Ramp.**

**R204.3, R304.2.2, STD 1115**

Total Cost: \$ 3080
