# Access Compliance Report Public Rights-of-Way (Curb Ramps)

| Main Street: ETON_PL | | Cross Street: O_NEILL_DR | | Location: | SE |
| ADA ID: RPRK211027115626 | Ramp Type: Type 6 - Directional 1 | Initial Pass/Fail: Fail | Overall Compliance: No | Severity Score: | 30 |

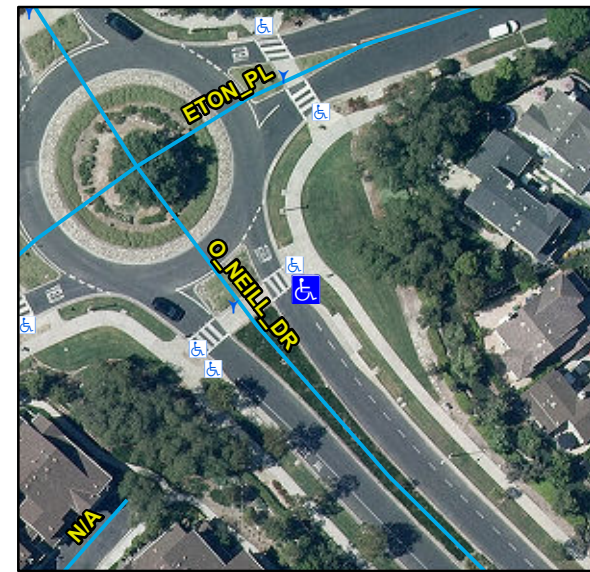
| Compliance | Description | Data | Compliance | Description | Data |
|---|---|---|---|---|---|
| No | Ramp Run Slope (%) | 12.1 | N/A | Flare Slope LT (%) | N/A |

**Remove & Replace Entire Ramp.**

**R204.3, R304.2.2, STD 1115**

Total Cost: \$ 3080
