# Access Compliance Report Public Rights-of-Way (Curb Ramps)

Main Street: O\_NEILL\_DR Cross Street: ETON\_PL Location: S

ADA ID: RPRK211027115828 Ramp Type: Type 6 - Directional 1 Initial Pass/Fail: Fail Overall Compliance: No Severity Score: 45

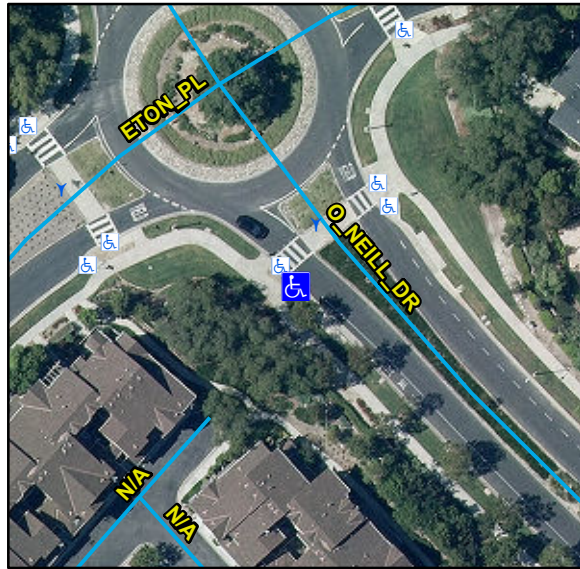
| Compliance | Description | Data | Compliance | Description | Data |
|---|---|---|---|---|---|
| No | Ramp Run Slope (%) | 9.1 | N/A | Flare Slope LT (%) | N/A |
| No | Ramp Cross Slope (%) | 9 | N/A | Flare Traversable LT | N/A |

Remove & Replace Entire Ramp.
