# Access Compliance Report Public Rights-of-Way (Curb Ramps)

Main Street: O\_NEILL\_DR Cross Street: ETON\_PL Location: SW

ADA ID: RPRK211027120334 Ramp Type: Type 6 - Directional 1 Initial Pass/Fail: Fail Overall Compliance: No Severity Score: 15

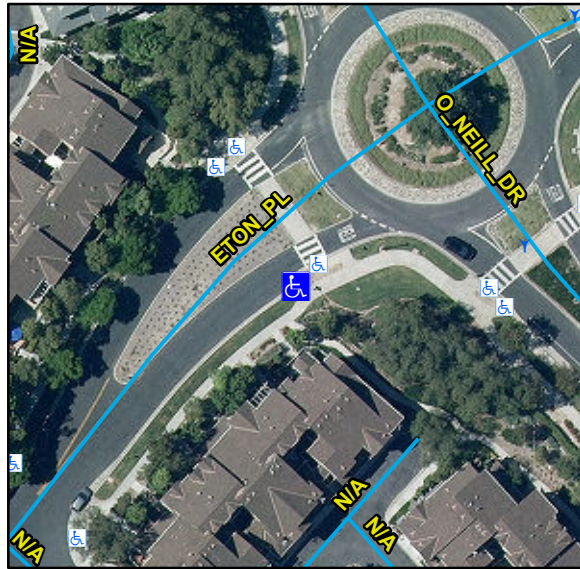
| Compliance | Description | Data | Compliance | Description | Data |
|---|---|---|---|---|---|
| No | Ramp Run Slope (%) | 11.1 | N/A | Flare Slope LT (%) | N/A |

Possible Solutions:

Remove & Replace Entire Ramp.

R204.3, R304.2.2, STD 1115
